CASE STUDY TERRA ALTA SKY LOUNGE MEMBRANE STRUCTURE IN EL SALVADOR CENTRAL AMERICA

Carlos E. Armendariz N./Crearquitectura

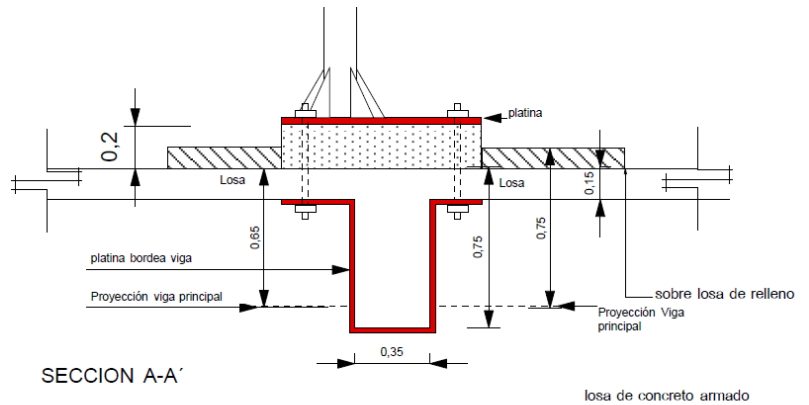
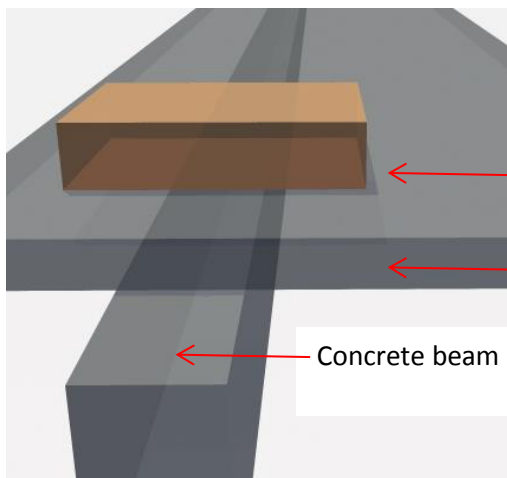
Since 15 cm of the top of the flagstone was just a filling. **Step 1** of the solution conceived was to build a double “foundation”.to increase the structural section of the base with new and more resistance concrete.

Added concrete

Original flagstone

Concrete beam

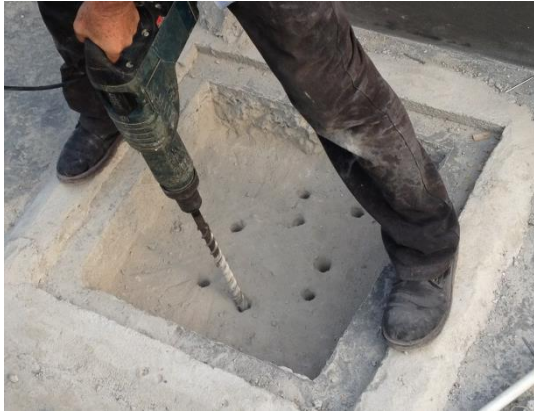
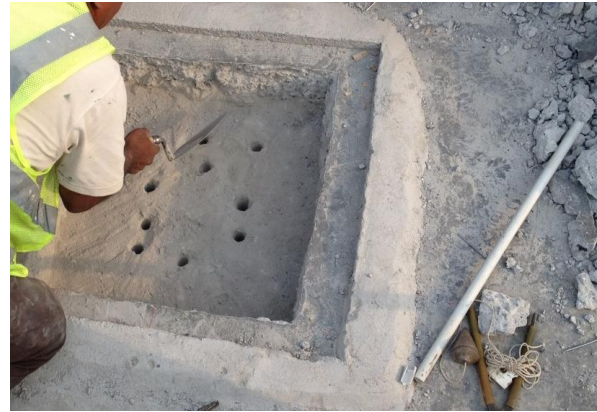
- A. The poor concrete filing was removed, and the perforations for the later placement of the steel bolts were made. Note that the perforations are not completely aligned due to the asymmetrical steel reinforcement of the flagstone

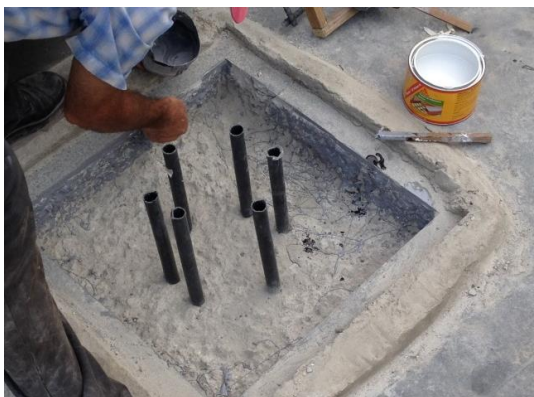
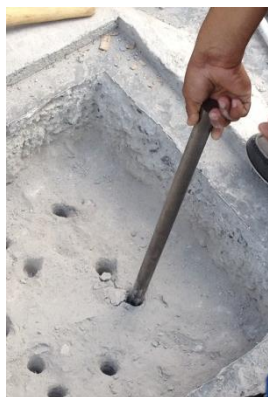
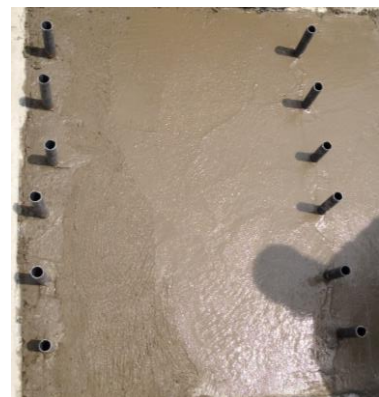
- B. Before the new concrete was poured we used SIKADUR 32 as an adherent bridge for the older and newer concrete. The diameter of each hole was rehearsed and pvc tubes were put into place, assuring the smooth later placement of the 1m long steel bolts.

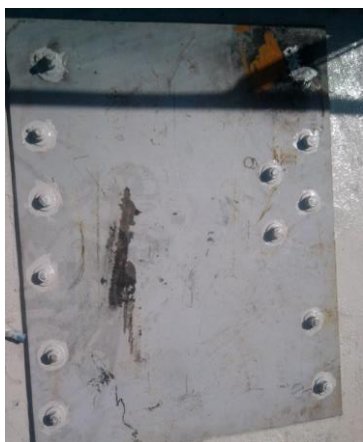
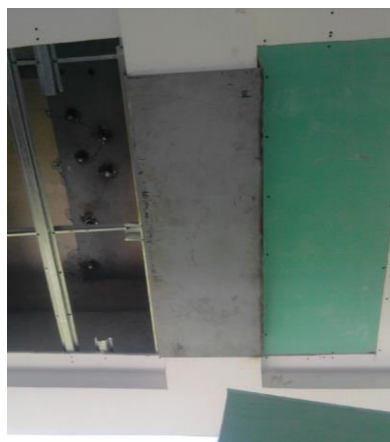
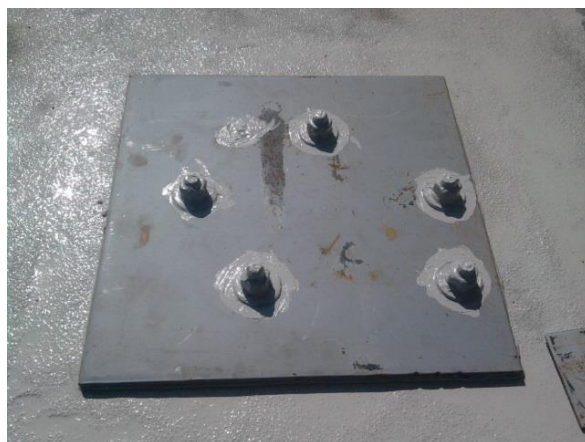
- C. After the concrete had dried, a stencil was drawn for the exact dimensions and perforations of the steel plates. The steel plates where then cut and perforated, and later where put in their right place above and beneath the flagstone. The steel bolts where

also placed and sealed to avoid corrosion and water penetration

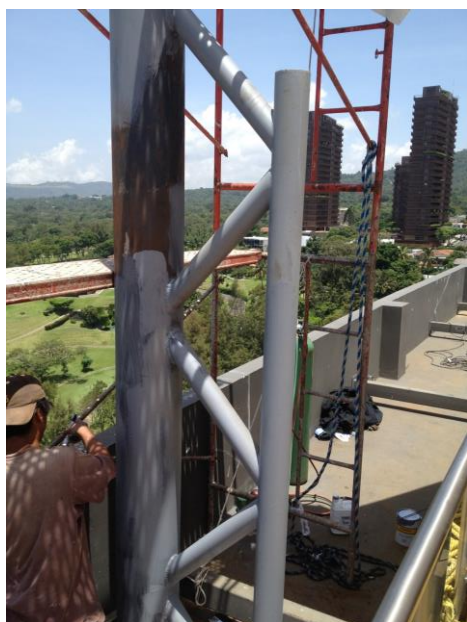
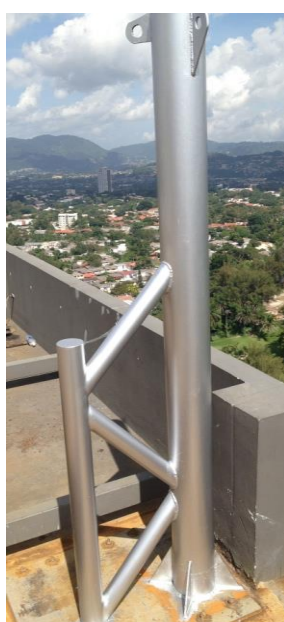
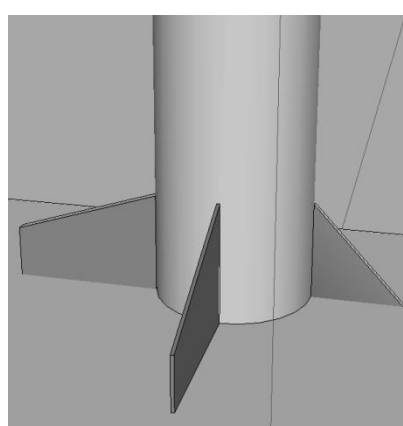
D. The joist elements where welded to the two main masts. And additional bracings where also placed at the base of each mast
